Clinical Brief

Treating Carious White Spot Lesions

Flowable composite offers ease of placement with bioactive benefits

Ron Kaminer, DDS

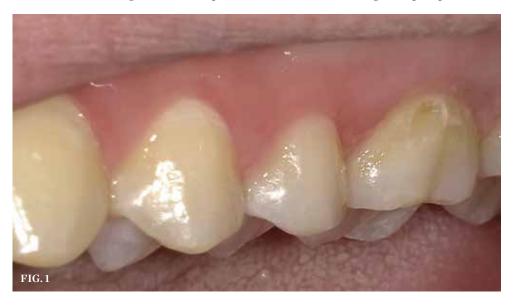
A new patient presented with a demineralized white spot lesion from an orthodontic bracket on tooth No. 14 that had become cavitated (Figure 1). A white spot lesion can be treated without marring the tooth if it is noncarious; however, once cavitated, it needs to be restored with either resin-modified glass ionomer or composite, and in severe cases, tooth reduction and veneer placement may be necessary.^{1,6} To evaluate whether a white spot lesion is cavitated or not, the tooth surface must be cleaned and dried.6 Carious white spot lesions are usually rough and porous in appearance, whereas noncarious ones are frequently smooth and shiny.6

(1.) Preoperative photograph of demineralized white spot lesion on tooth No. 14.

Treatment options were discussed with the patient, and a mutual decision was made to restore the tooth using bioactive composite

material to prevent further deterioration of the tooth structure and maintain an esthetically acceptable appearance.

The existing decay was removed using a 330 carbide bur (NeoBurr® Carbide, Microcopy). To create a gradual transition between the tooth structure and restorative material that would enhance retention and prevent microleakage, the buccal surface of the tooth was beveled 2 mm on all sides (ie, occlusal, mesial, distal, cervical) using a flame-shaped diamond (NeoDiamond® Burs, Microcopy) (Figure 2).7 After the bevel was completed, the preparation was selectively etched at the periphery of the enamel using 35% phosphoric acid
